ANNEXE C – SURFACE WATER DRAINAGE SURVEY APRIL TO JUNE 2020

(with amendments and additions to February 2021)

Carried out by
Andrew Scarth CEng FICE

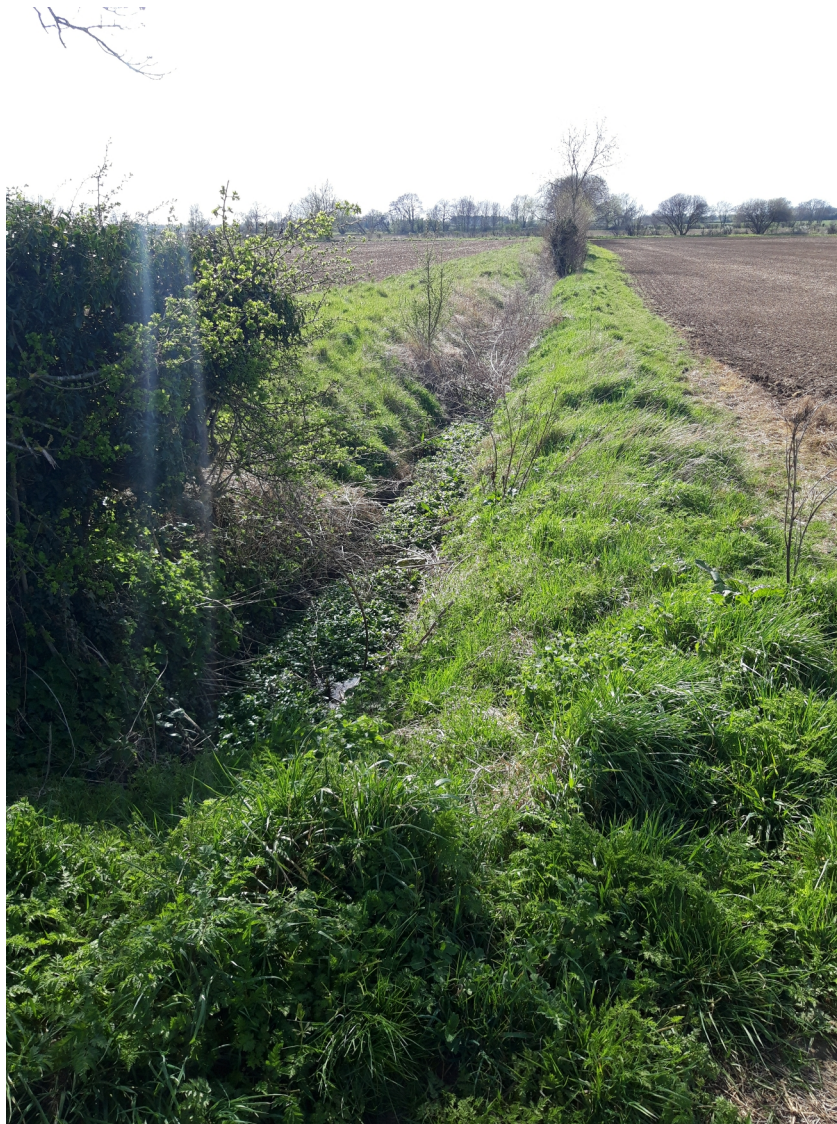
Photograph 1 - Drain A

Photograph 1 shows Drain A from the pipe under Charlham Lane track looking west. Some overgrown vegetation is evident.

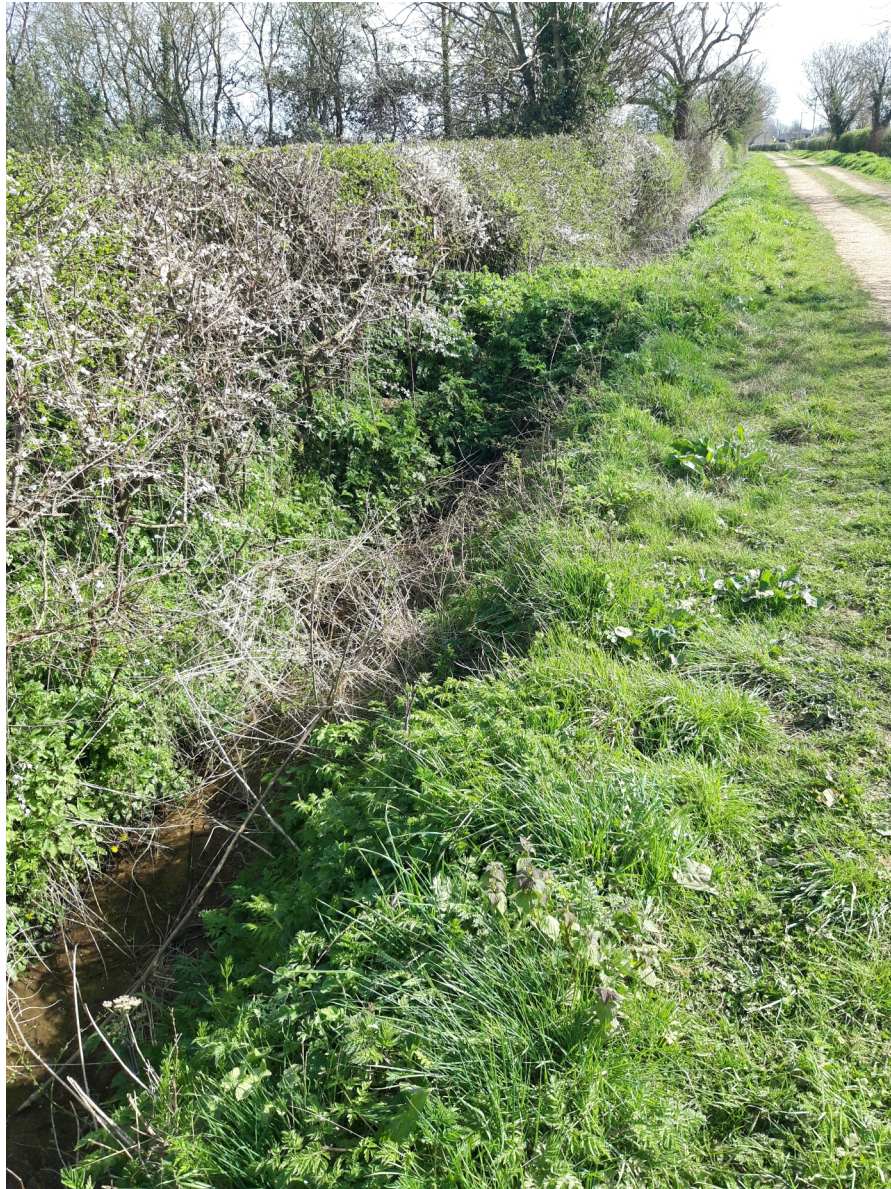
Photograph 2 – Drain B1 looking south showing obstruction

At the time of writing the Drain B1 is blocked between its junction with Drain C and its junction with Drain A. The drain and the obstruction can be seen in Photograph 2.

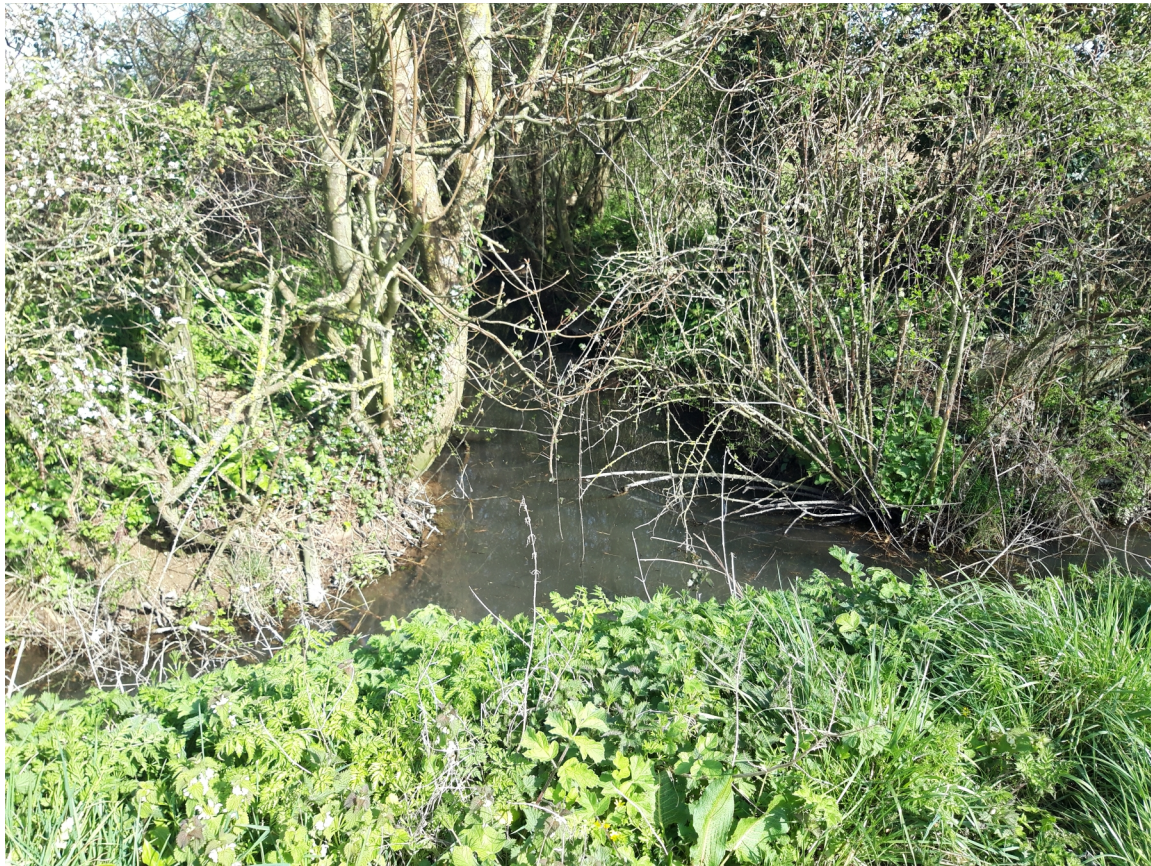
Photograph 3 – Drain C and Drain B1 junction

The junction with Drain C is shown in photograph 3. It is noticeable that even after a stretch of dry weather water is flowing from Drain C. This is noted later in the next section.

The water flowing at the junction between Drains C and B1 mentioned in the last section is coming from the pipe from Linden Lea. Water could be seen flowing from it. This part of the drain is very overgrown.

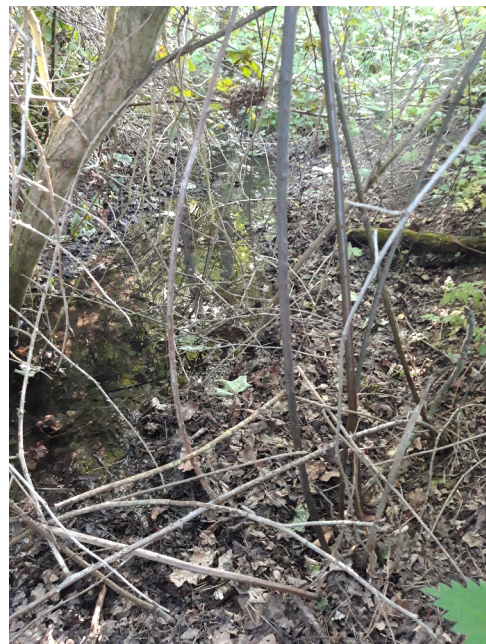
Photograph 4 – Drain C at the right angle bend

Drain C runs northwards from the end of Suffolk Place, picking up the 1050 mm pipe from Linden Lea before turning at a right angle to join Drain B1. Photograph 4 is taken at the bend

Drain C runs through a heavily wooded corridor which can be seen in Photographs 4 and 6.

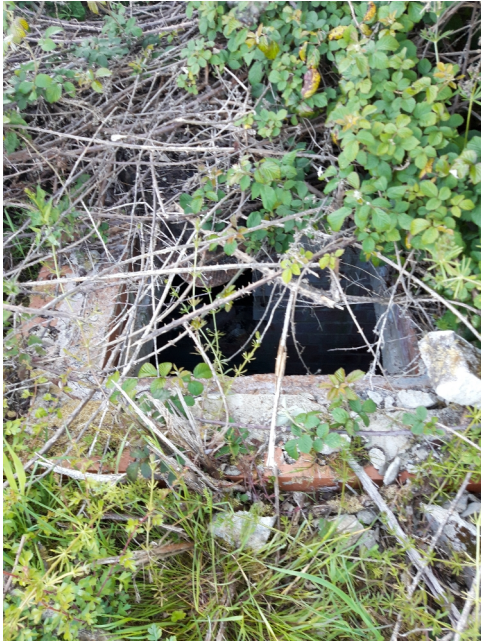
Photograph 5 - Manhole

There is a manhole at the junction with the pipe leading from Linden Lea. This is shown in Photograph 5. At the time of writing the manhole cover and frame were displaced and there appears to be some damage within the manhole (Photograph 5a).

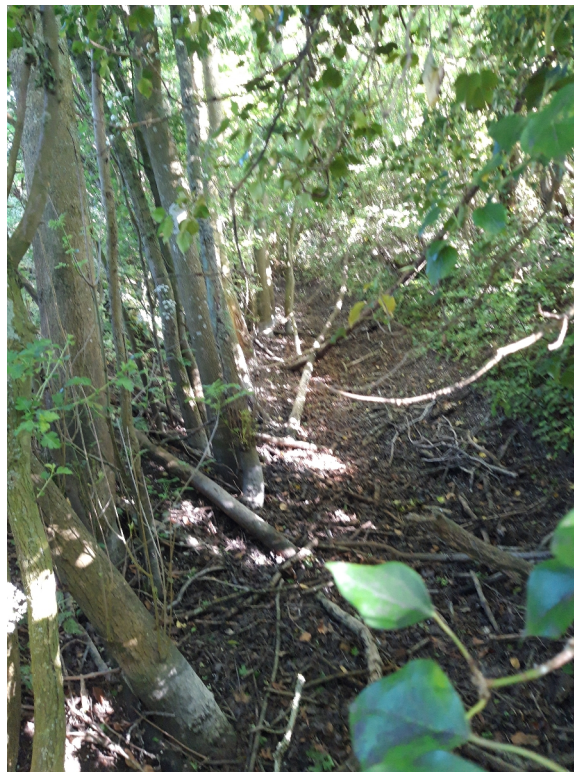
Photograph 6 - Drain C looking South

Photograph 6 is taken from further upstream near the start of Drain C at the end of Suffolk Place.

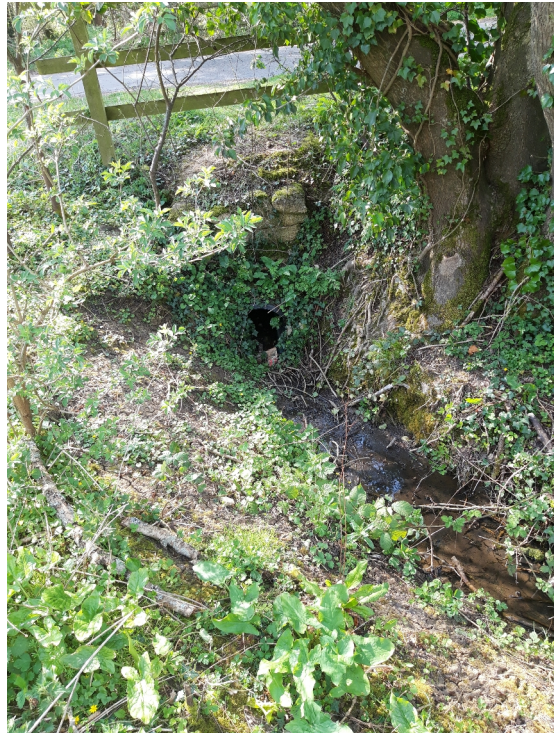
Photograph 7 - Drain E Looking back to Oak Road

Photograph 7 is the start of Drain E from where the pipe joining Drain D to it passes under Oak Road.

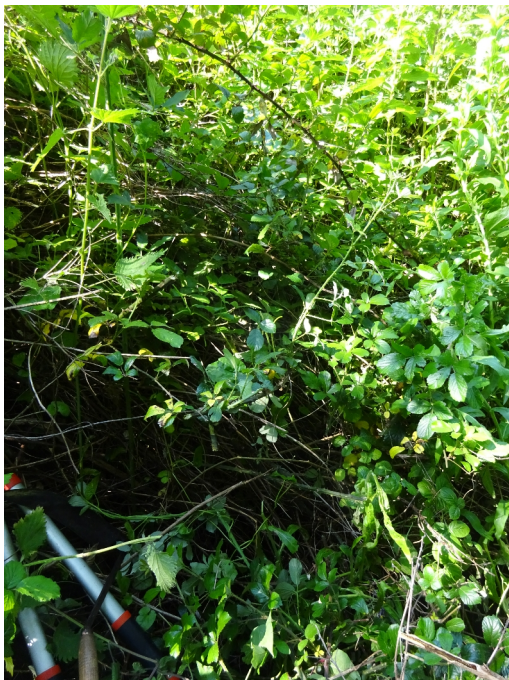
Photograph 8 - The point where the 9" pipe joins Drain E

Photograph 8 is where the 9" pipe mentioned above joins the Drain E. Drain E is very overgrown but after clearing the area it is possible to see a dry-stone headwall (Photograph 9). It was not possible to see the the pipe and confirm that it is 9" diameter pipe (see also the section on Pipe B).

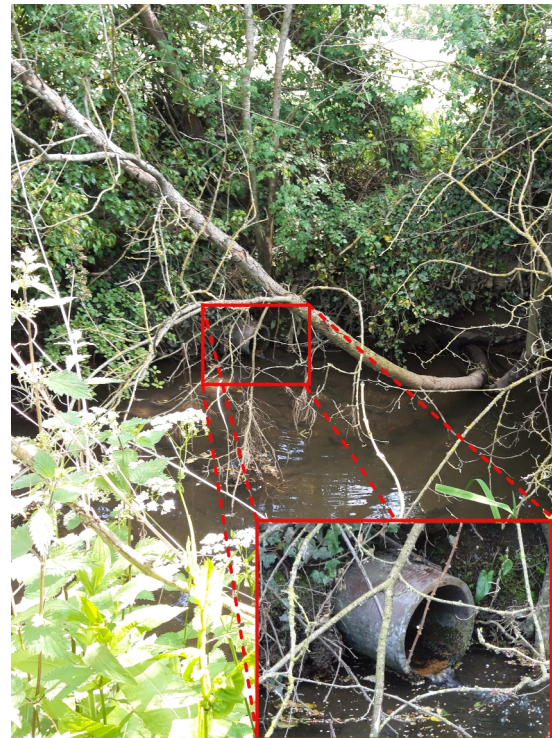
Photograph 10 – Highway drain outfall into Poulton Brook

As was mentioned earlier under section 3 on Drain B the bottom end of Drain B2 and the highway drainage from Chestnut Close, Suffolk Place and the west end of Main Street outfalls into Poulton Brook (see Photograph 10). It is worth noting that water is flowing from the outfall despite there having been no rain for several weeks at the time of Photograph 10. It was noted that Poulton Brook is overgrown at this location and downstream to its confluence with Ampney Brook. From observation the outfall is a 12" pipe. The basic slope on the pipework must be in the region of 1 in 200; applying the Manning formula the maximum flow rate should be about 60 litres/sec.

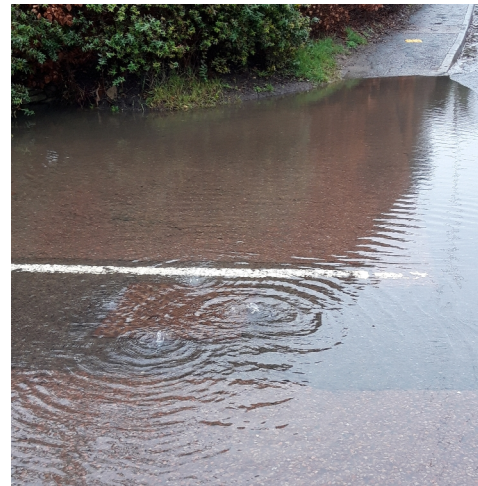
Photograph 11 - The end of Charlham Lane (31/01/2021)

In times of heavy rainfall Poulton Brook runs bank full and standing water is observable from the Red House eastwards as far as Charlham Lane. On 30th January 2021 water could be seen bubbling from the manhole at the bottom of Charlham Lane (see Photograph 11). The head difference between this standing water and the water in Poulton Brook when this photograph was taken, however, would still be in the region of 0.5 metres (See next paragraph) therefore the flow rate should be nearly 40 litres/sec. This was clearly not the case when Photograph 11 was taken. A number of the gullies were not taking an appreciable quantity of water. The conclusion can only be that the road drainage pipes were blocked or restricted on that date. Cleaning and jetting was carried out at the beginning of February 2021. This may have solved the problem.

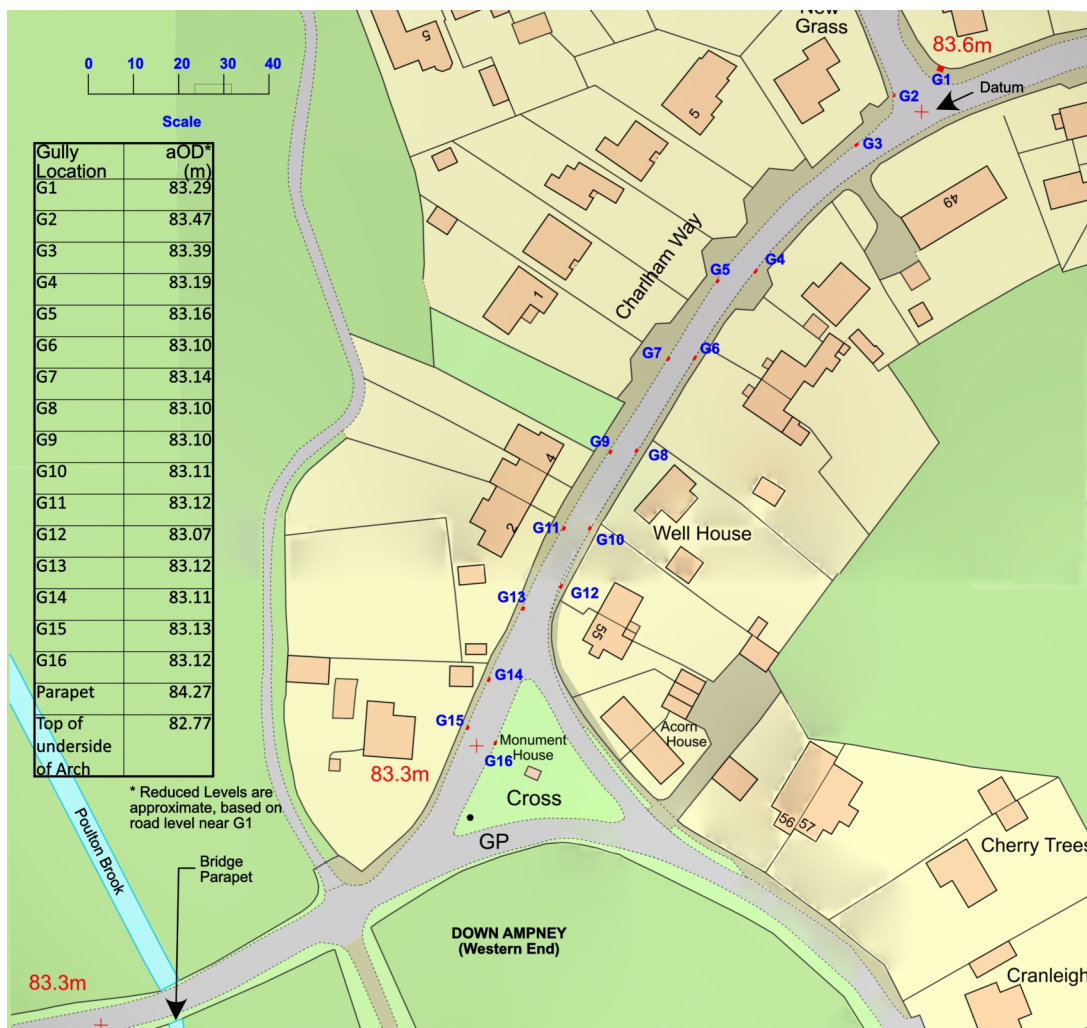
A level survey was undertaken by the author on 10 February 2021 to ascertain the relative levels of the gully gratings and Poulton Brook where the road drainage outfalls. The information is given below.

The minimum height difference between the lowest gully grating and the underside of the bridge at Poulton Brook is 0.3 metres. The author (resident in the village for 40 years) has never seen Poulton Brook this full even in the storm of July 2007. A realistic maximum would be 0.5 metre difference. This is still quite small but should be enough to prevent ponding between the Red House and the bottom of Charlham Lane, provided that the pipes are cleaned and jetted regularly and not just after a storm event when it is too late.

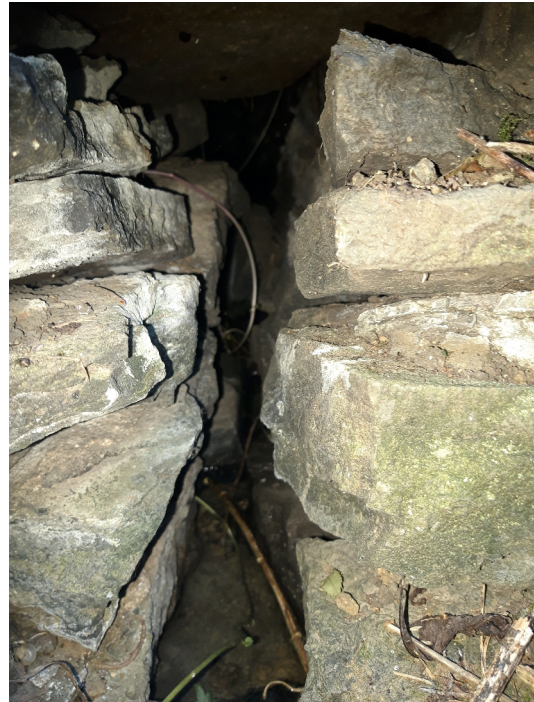
Photograph 12 – Inside the dry-stone outfall

Pipe B is apparently a 9" clay pipe. The fall on the pipe is unlikely to be greater than 1 in 500. The flow rate calculated from the Manning formula is less than 20 litres/sec. As noted under the section on Drain E it was not possible to positively identify the size of the pipe because the outfall is a dry-stone construction with only a slit exit. Photograph 12 is an attempt to see behind the dry-stone headwall.
