ANNEXE C – SURFACE WATER DRAINAGE SURVEY APRIL TO JUNE 2020

(with amendments and additions to February 2021)

Carried out by
Andrew Scarth CEng FICE

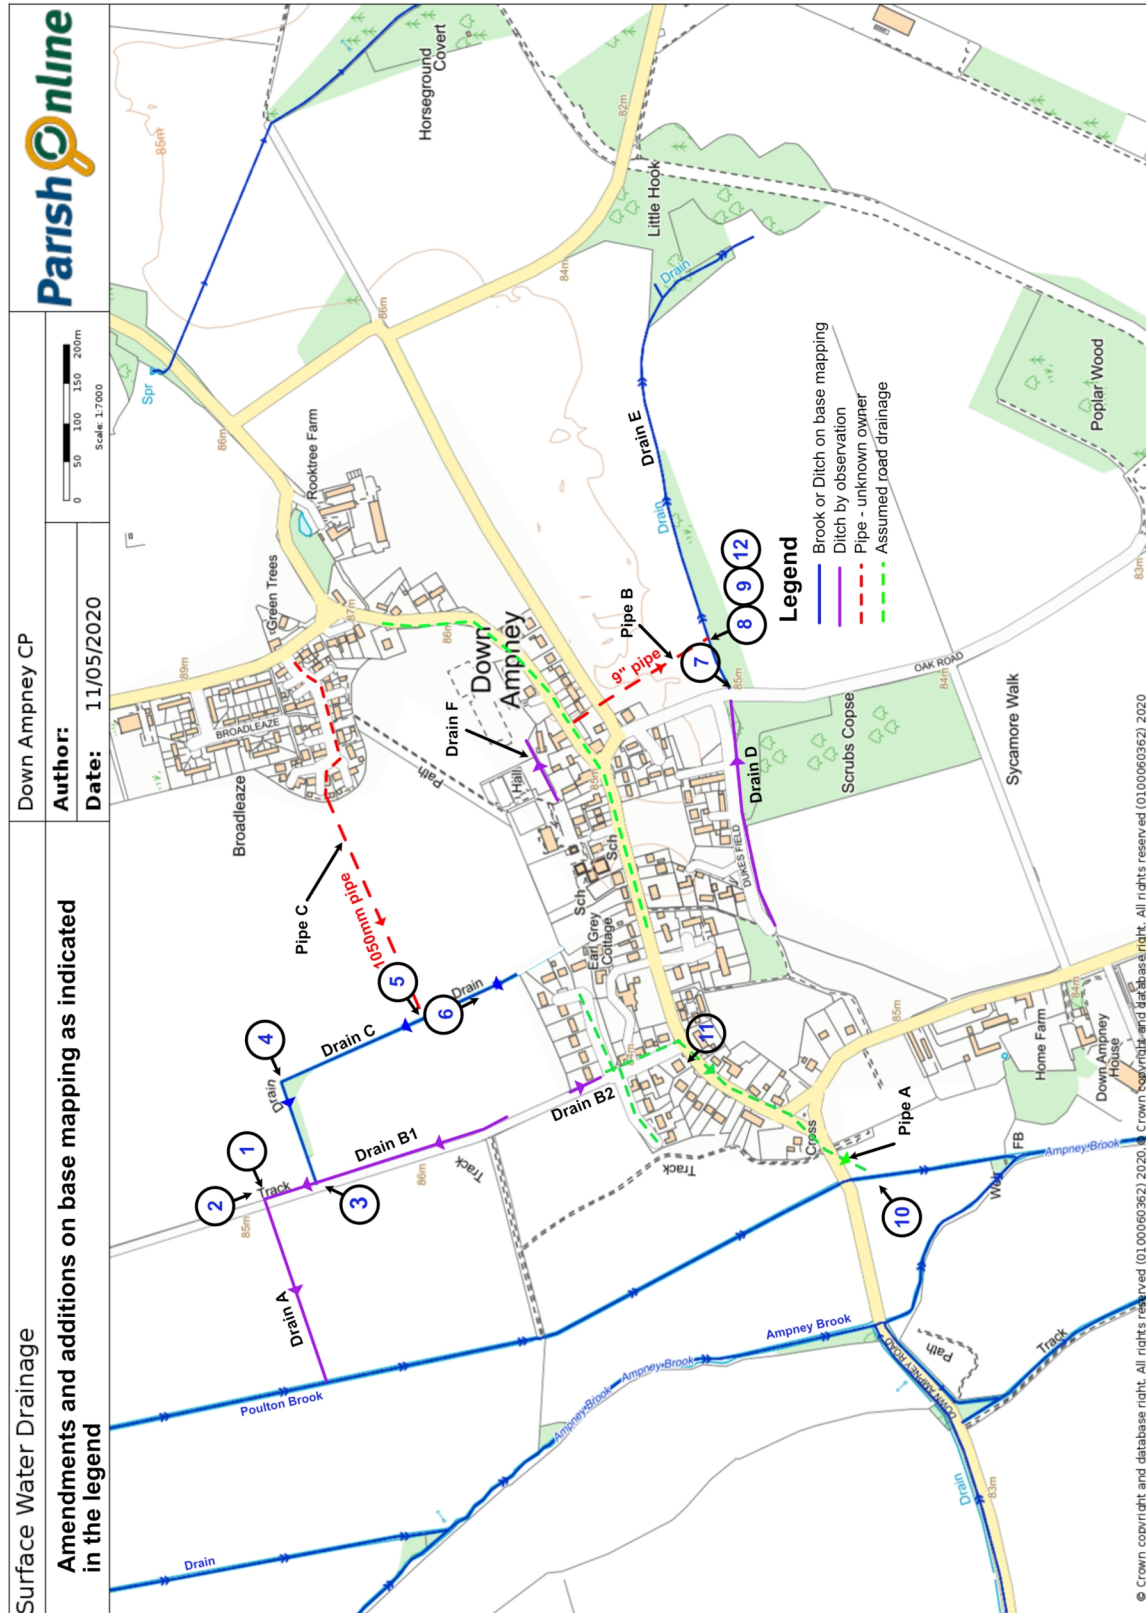
In April and May 2020 the author carried out a walk round survey of the ditches and drains surrounding the village of Down Ampney. This paper indicates the results. A location plan of the drains and ditches is shown overleaf.

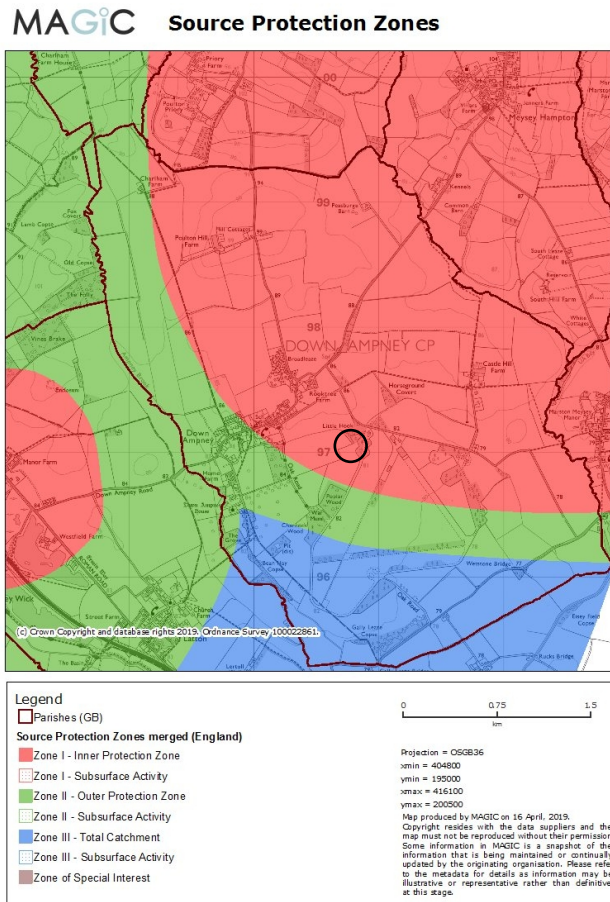
Drain E terminates at the woodland of Little Hook near the north-east of the old airfield. This area is within a groundwater Source Protection Zone 1 designated by the Environment Agency for water resources.
